Manhole Inspection Summary

Manhole # S29M__015MH

Insp Date: **5/21/09 12:02 PM**

Location Address: **1004 CROSS-WYETH-ALLEY**

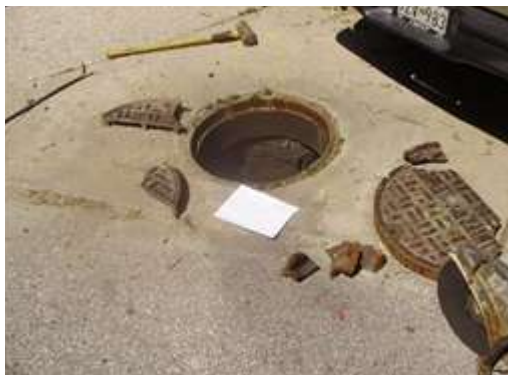
MISC.

BROKE AND REPLACED COVER

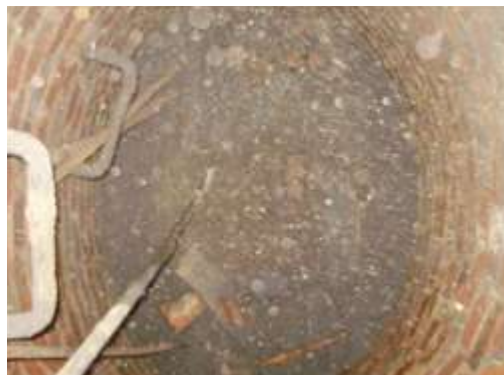
Defect 1

Condition: ☐ Sound ☐ Cracked ☐ Root Intrusion ☐ Deteriorated ☐ Leaks ☒ **Debris**

Steps Count: **3** Missing: **0** ☒ **Corroded**

DEBRIS IN TERMINAL CHANNEL;
CORRODED STEPS

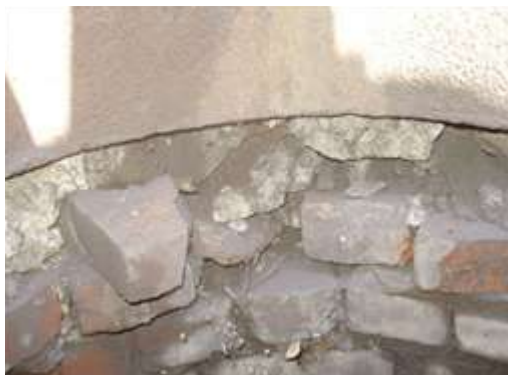
Defect 2

Condition: ☐ Sound ☒ **Cracked** ☐ Root Intrusion ☒ **Loose Brick** ☒ **Deteriorated**

chimney is deteriorated with loose &
cracked brick
